Charge Gas Compressor Fourth Stage Vibration

Johnny Dugas
Senior Technical Associate
DuPont Sabine River Works
Orange, Texas

Problem

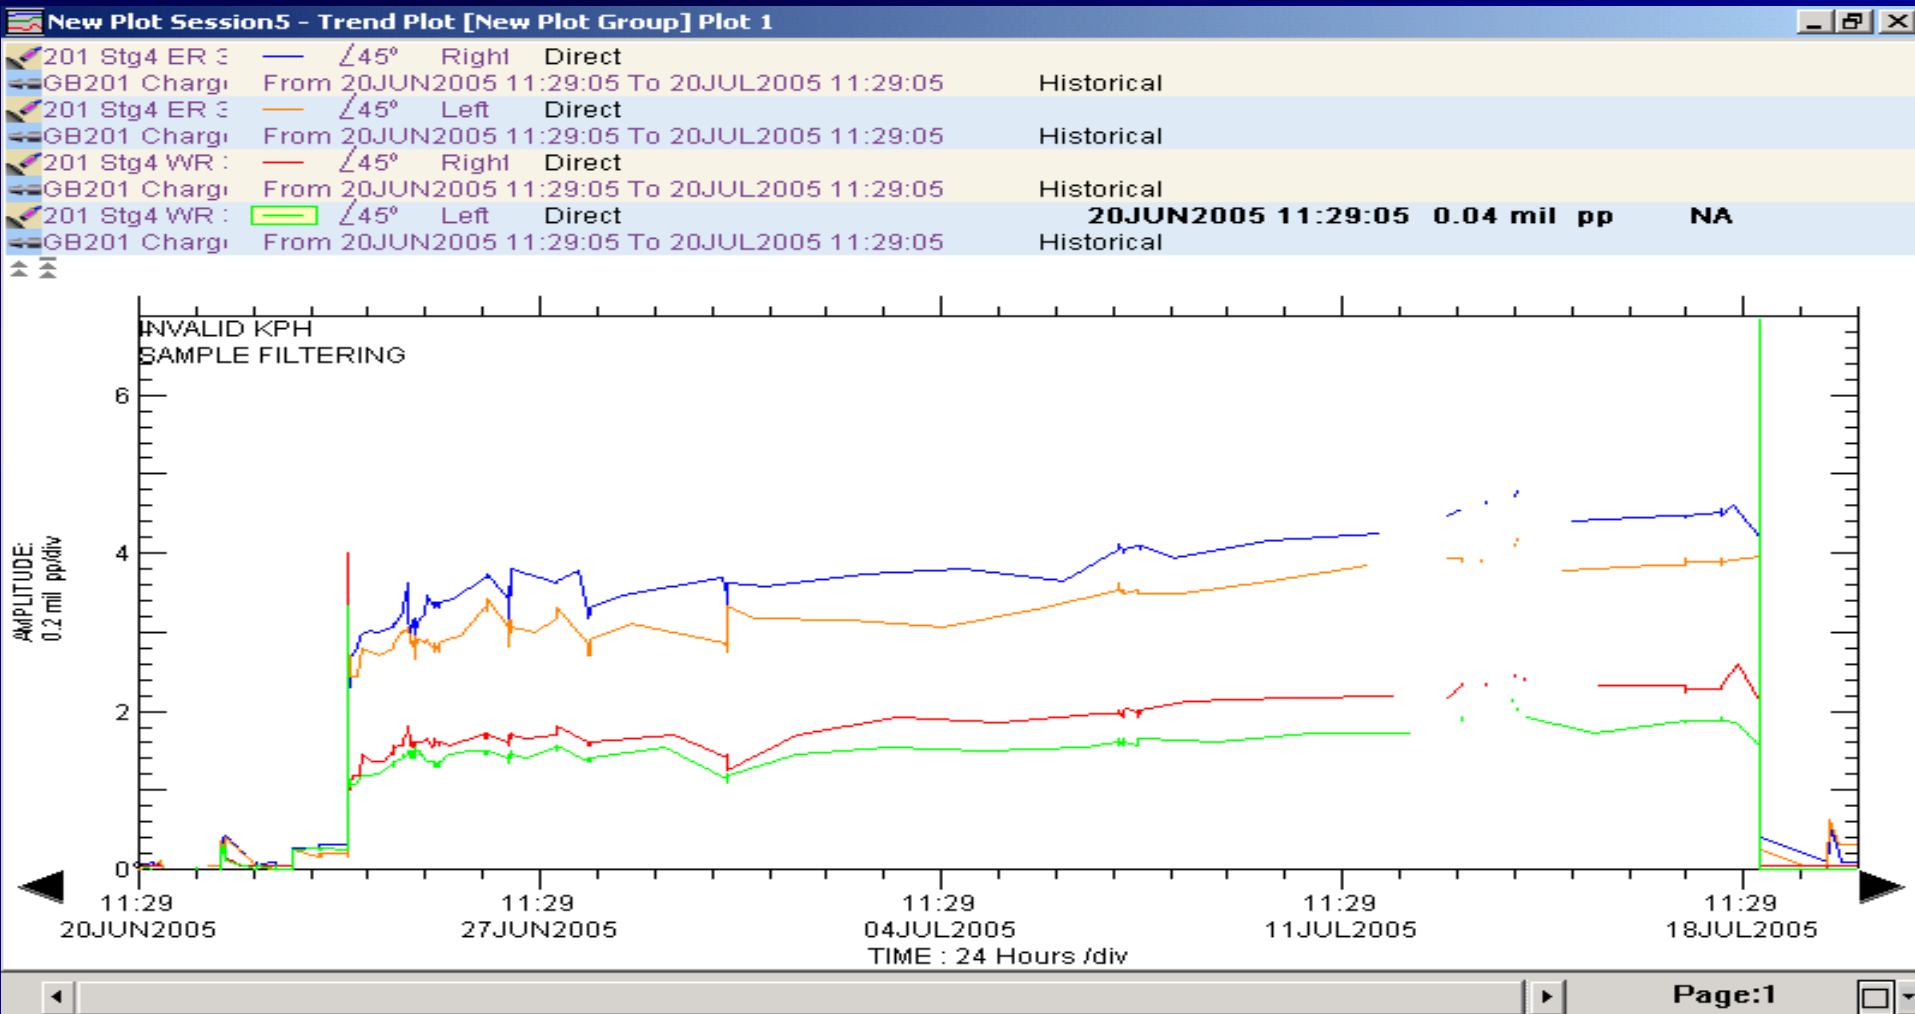
4th Stage Vibration Trend

- Radial Vibration Spiked to 4 mils Upon Start-up from 2/3 Stage Outage
- Internal Fouling was the Suspected Cause

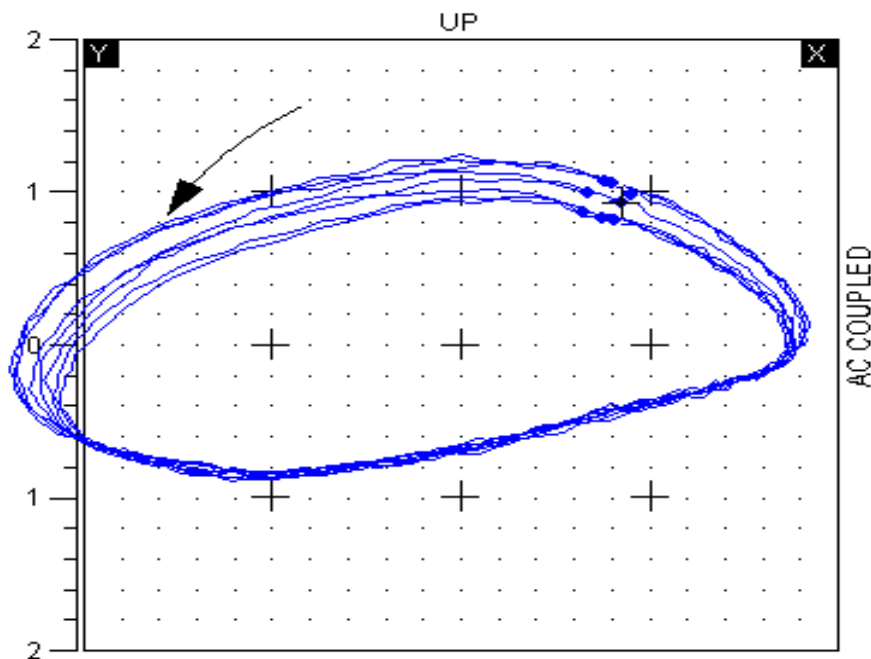
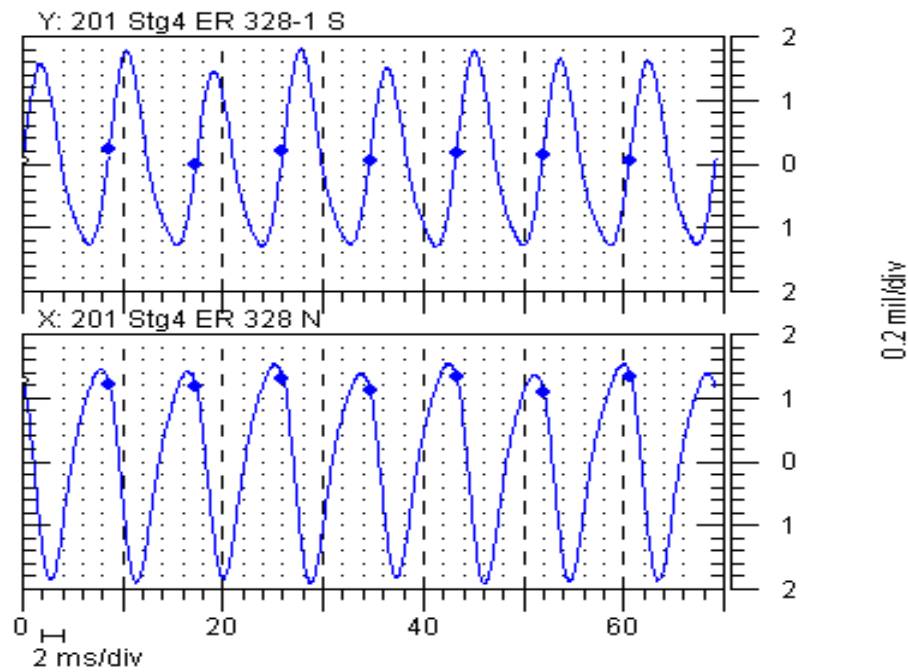
4th Stage Orbit

Y: 201 Stg4 ER 328-1 S $\angle 45^\circ$ Left SYNCH WF AMP : 3.12 mil pp
X: 201 Stg4 ER 328 N $\angle 45^\circ$ Right SYNCH WF AMP : 3.46 mil pp
GB201 Charge 30JUN2005 17:55:11 HW Alert/Alarm Direct 6929 rpm
FS: 0-64 X SMPR: 128/8

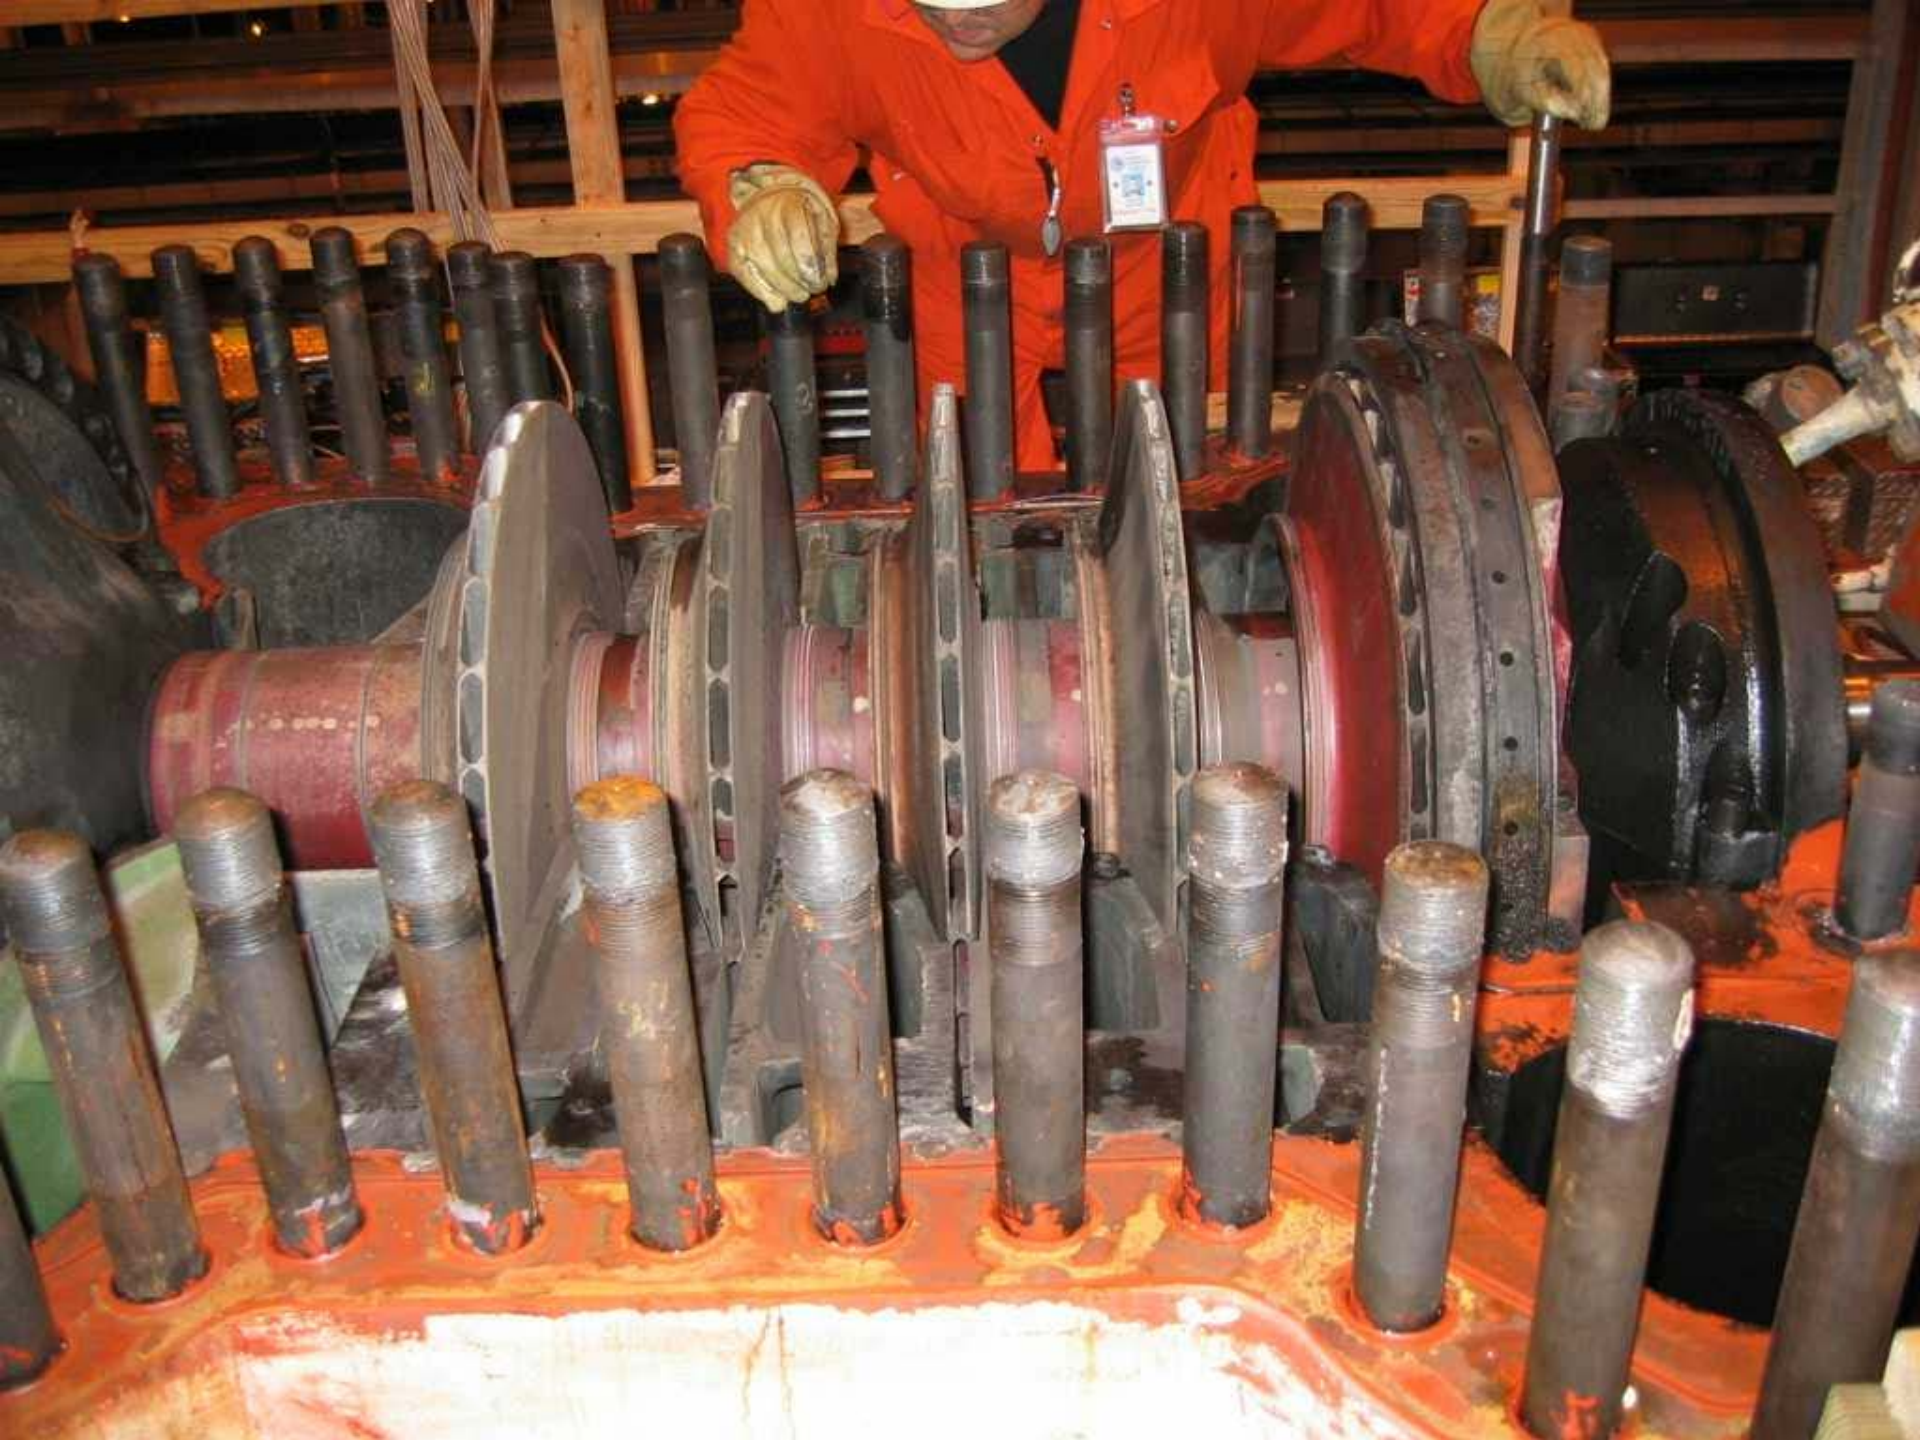
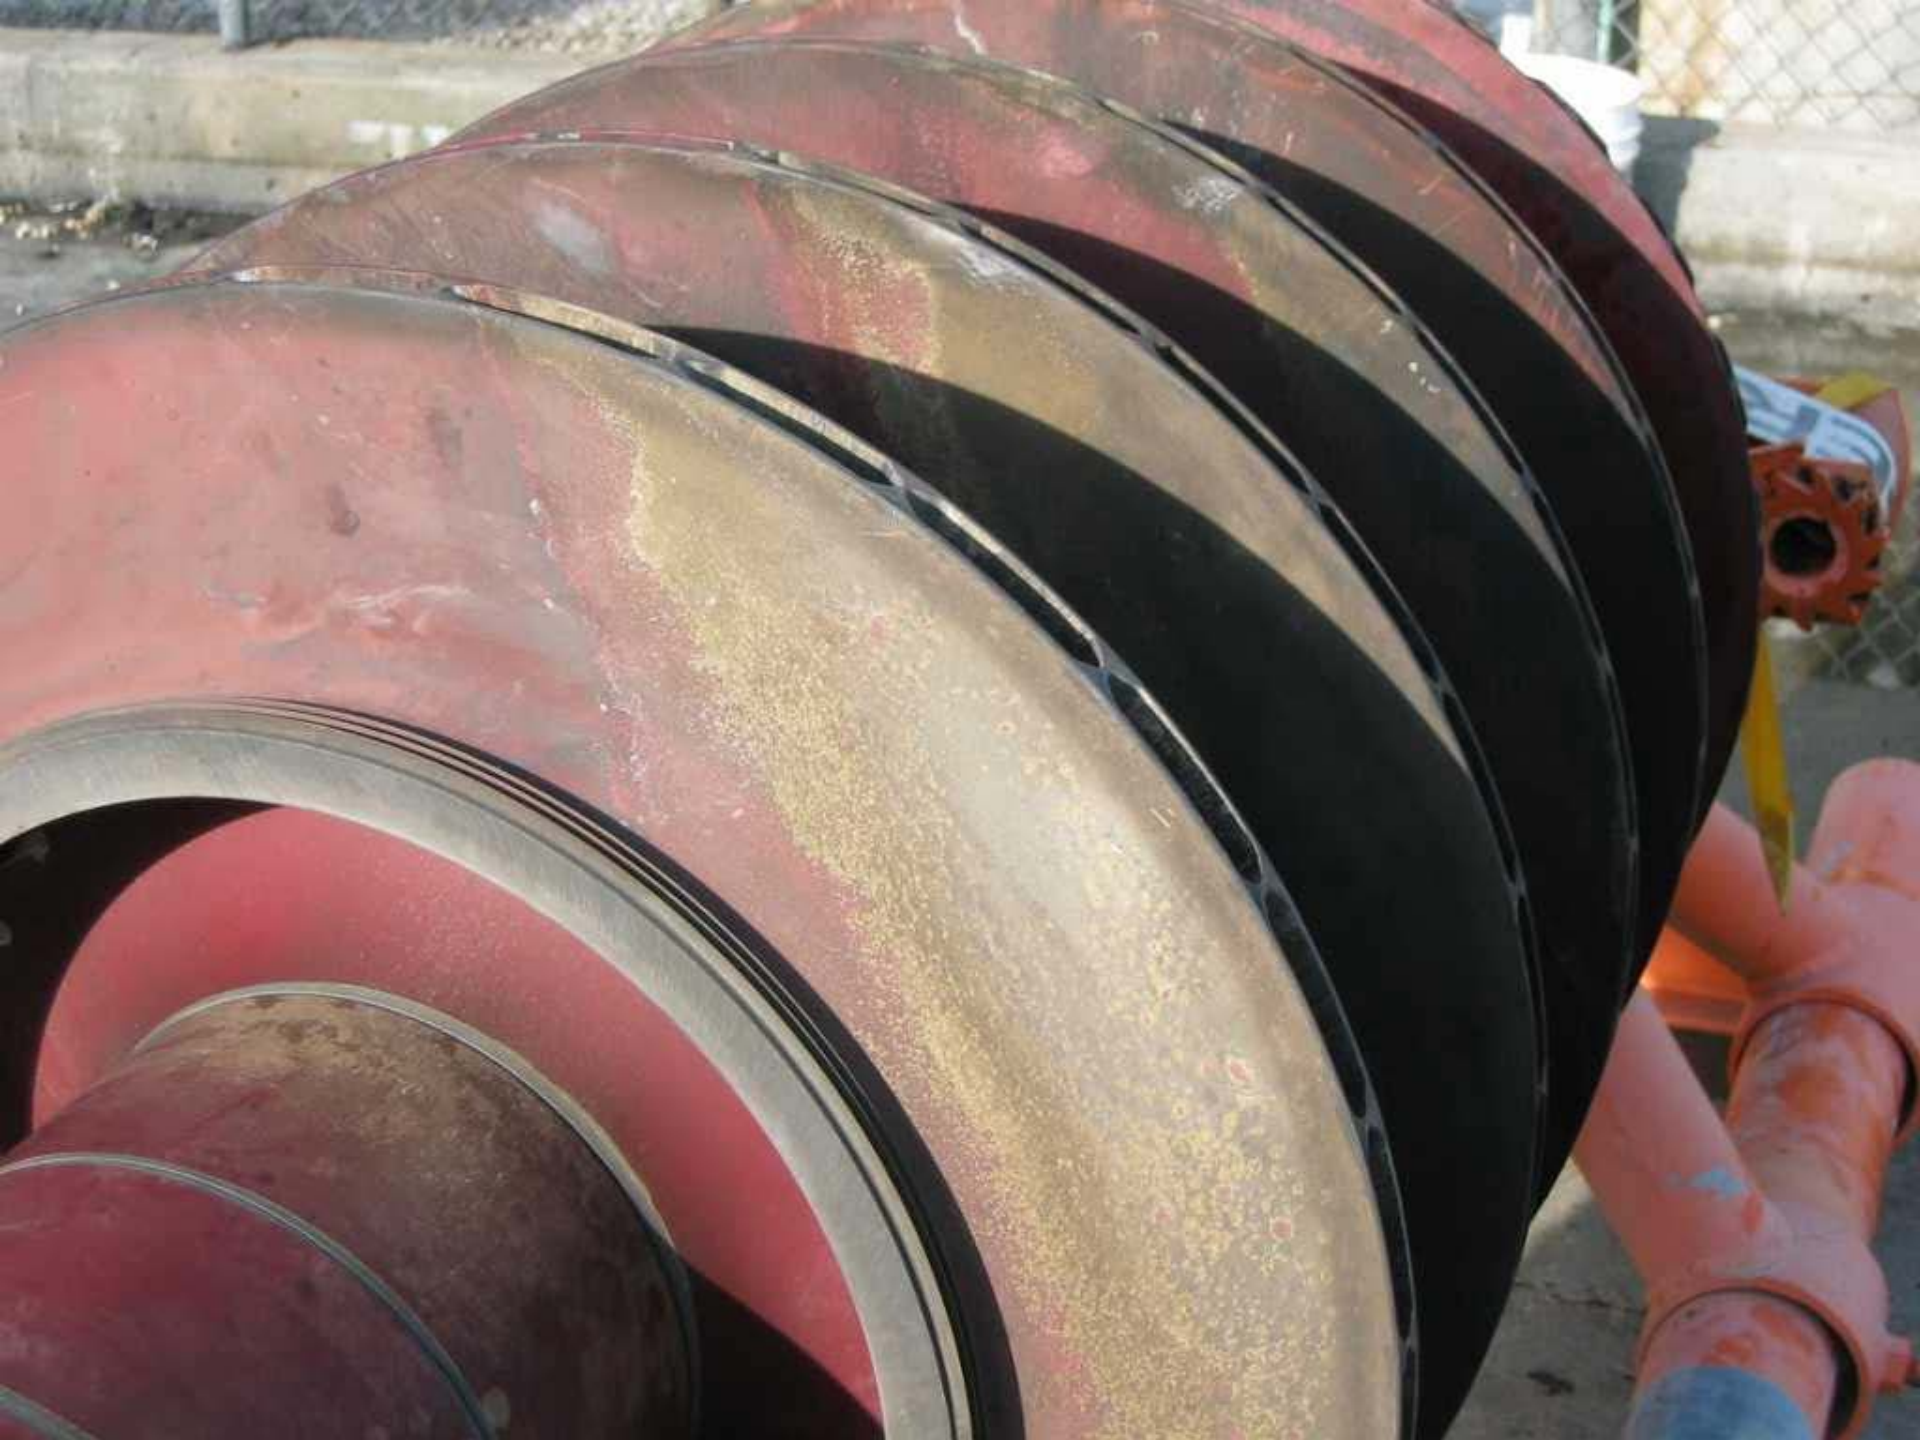
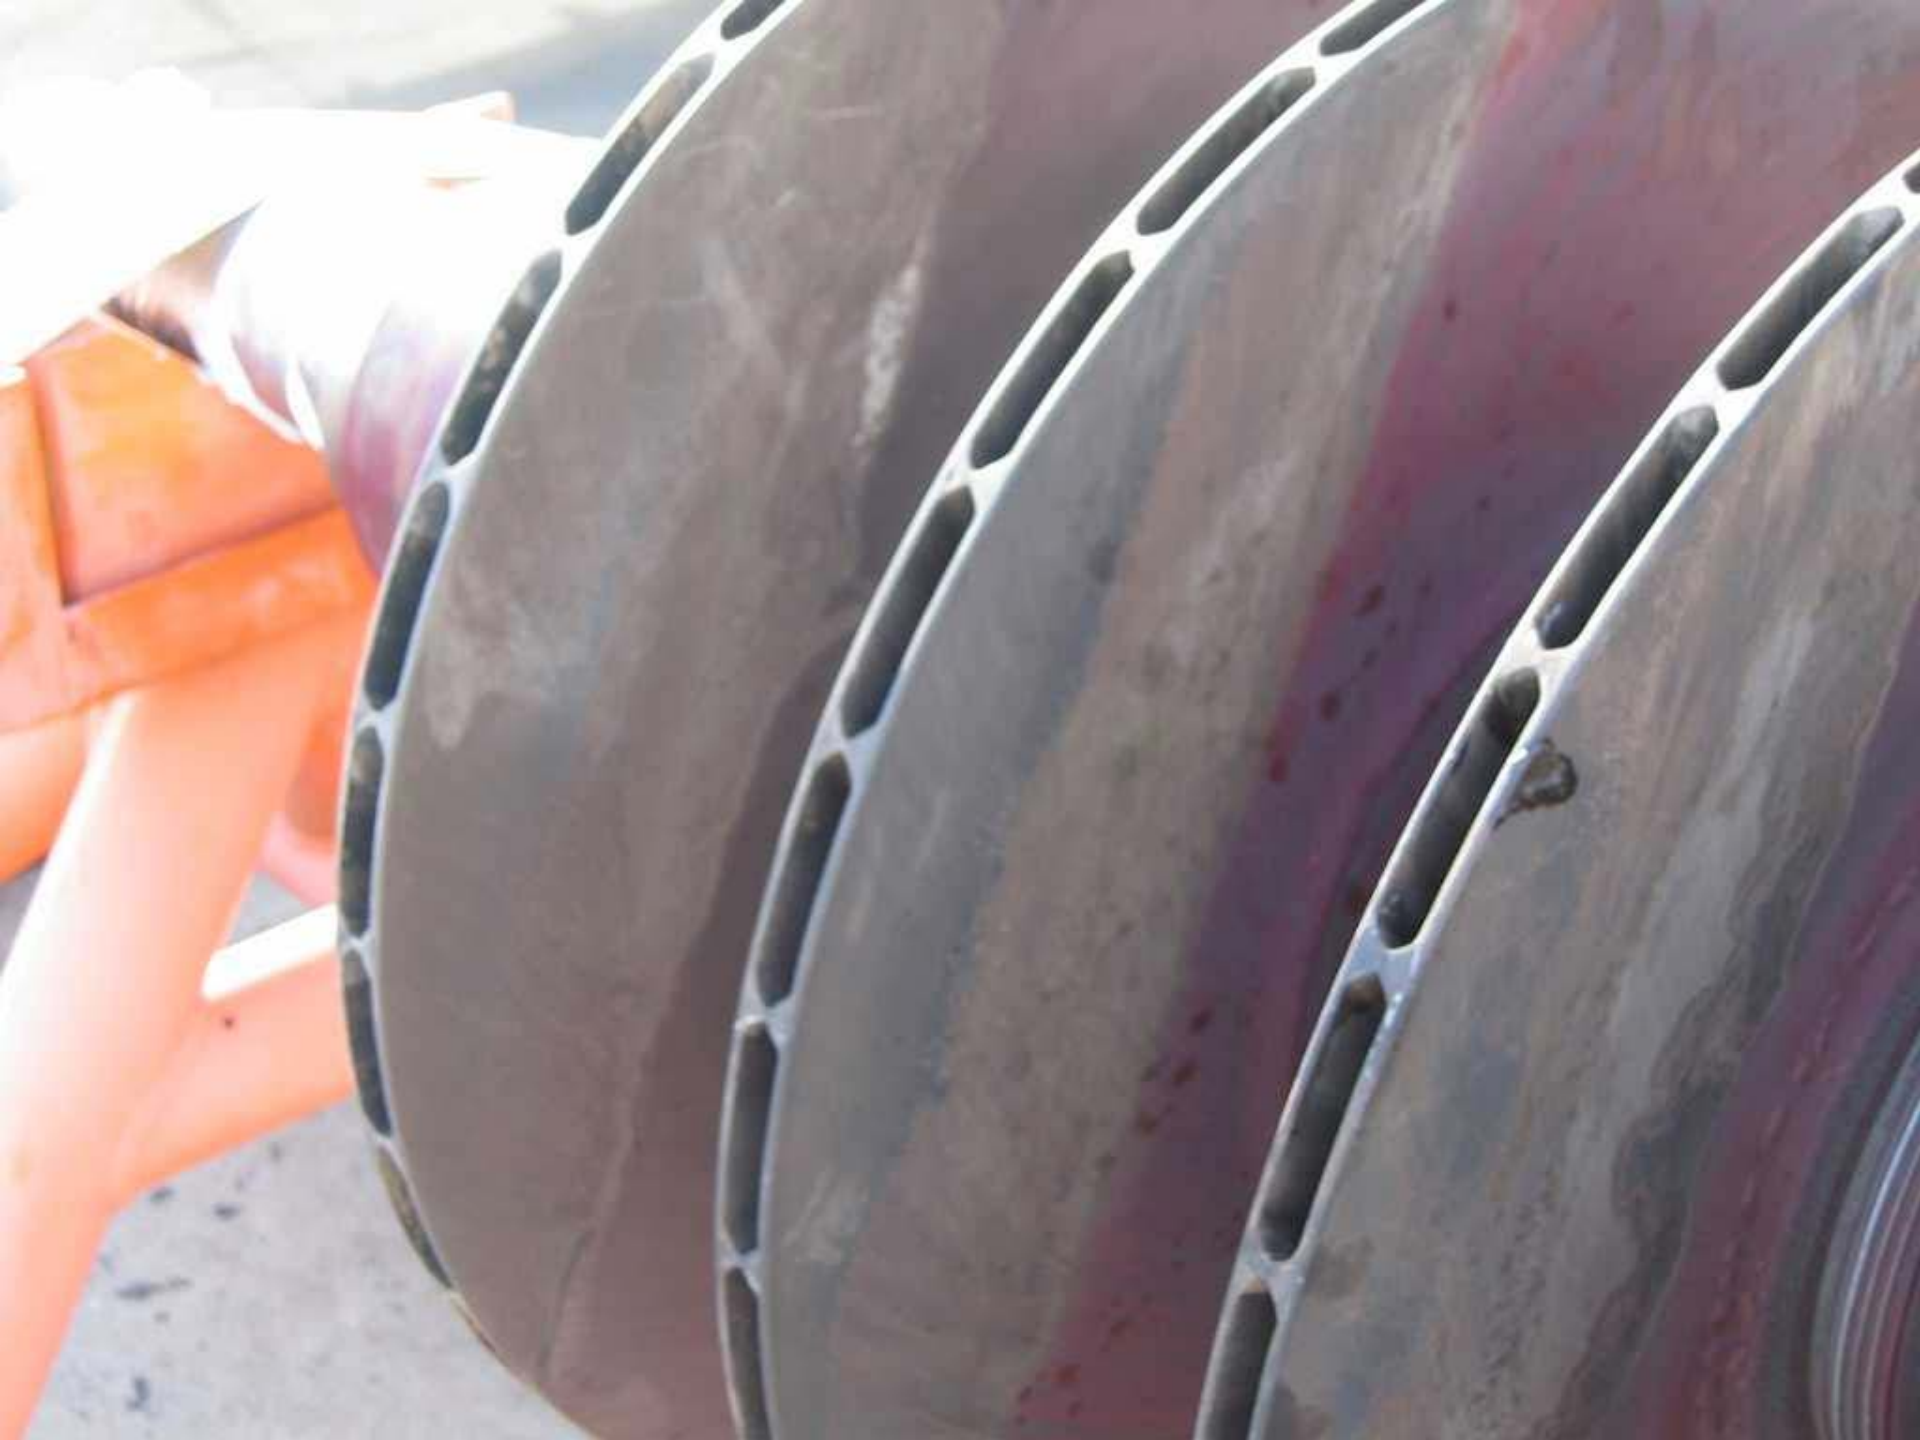
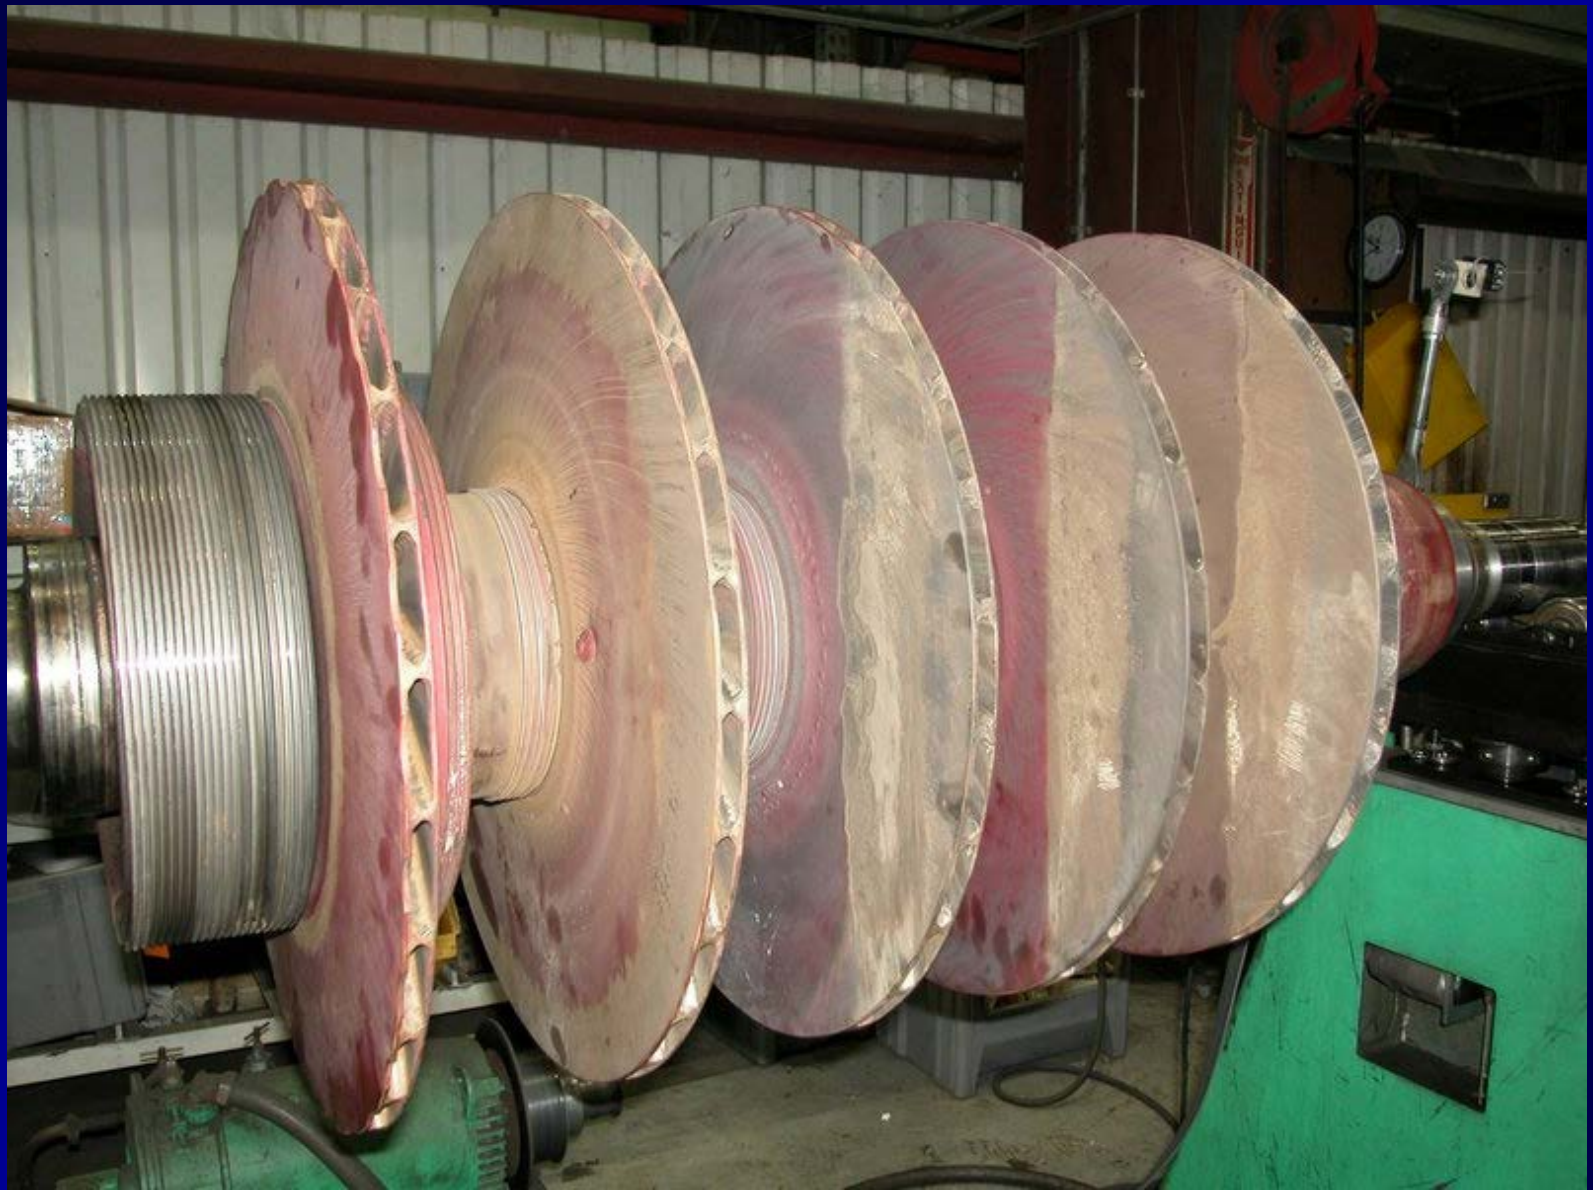
- Opened Case and Found Indications of a Watermark on Rotor and Diaphragms
- Close Examination Showed Top Layer of Antifoulant Coating was Missing

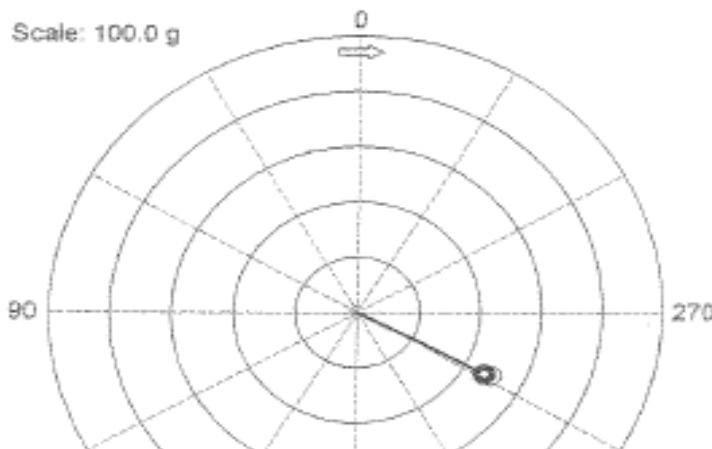
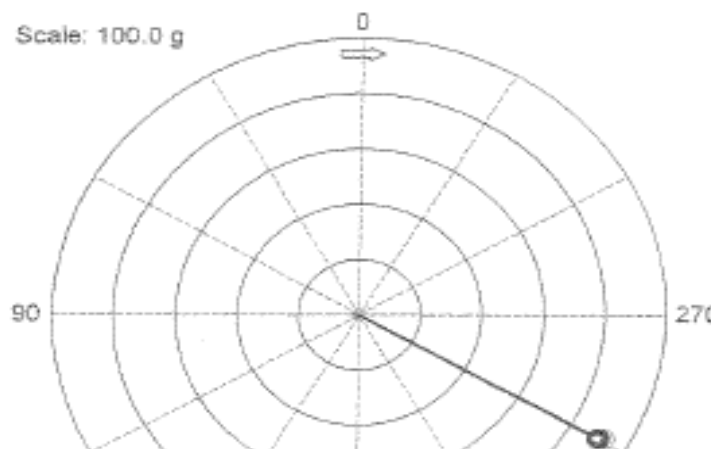
As-Found Rotor Balance Check

Left Radius 6.000 inch	Distance a 15.750 inch	Distance b 42.500 inch	Distance c 61.250 inch	Right Radius 6.500 inch
Balancing speed 705 RPM		Left Tolerance 14.770 g-inch	Right Tolerance 15.791 g-inch	
INITIAL RESULT:				
Correction Weight: Unbalance:	Left - 49.167 g at 242° 295.005 g-inch Reject (19.97 x Tol)		Right - 91.481 g at 241° 594.629 g-inch Reject (37.66 x Tol)	
CURRENT RESULT:				
Correction Weight: Unbalance:	Left - 47.117 g at 242° 282.702 g-inch Reject (19.14 x Tol)		Right - 89.982 g at 240° 584.883 g-inch Reject (37.04 x Tol)	
<p>Scale: 100.0 g</p>

- 585 Gram-inches Unbalance on Suction End of Rotor
- 283 Gram-inches Unbalance on Discharge End of Rotor
- Phase Angle Essentially Identical
- 2560 Pounds of Force at 7000 rpm (Rotor Weighs 1409 Pounds)

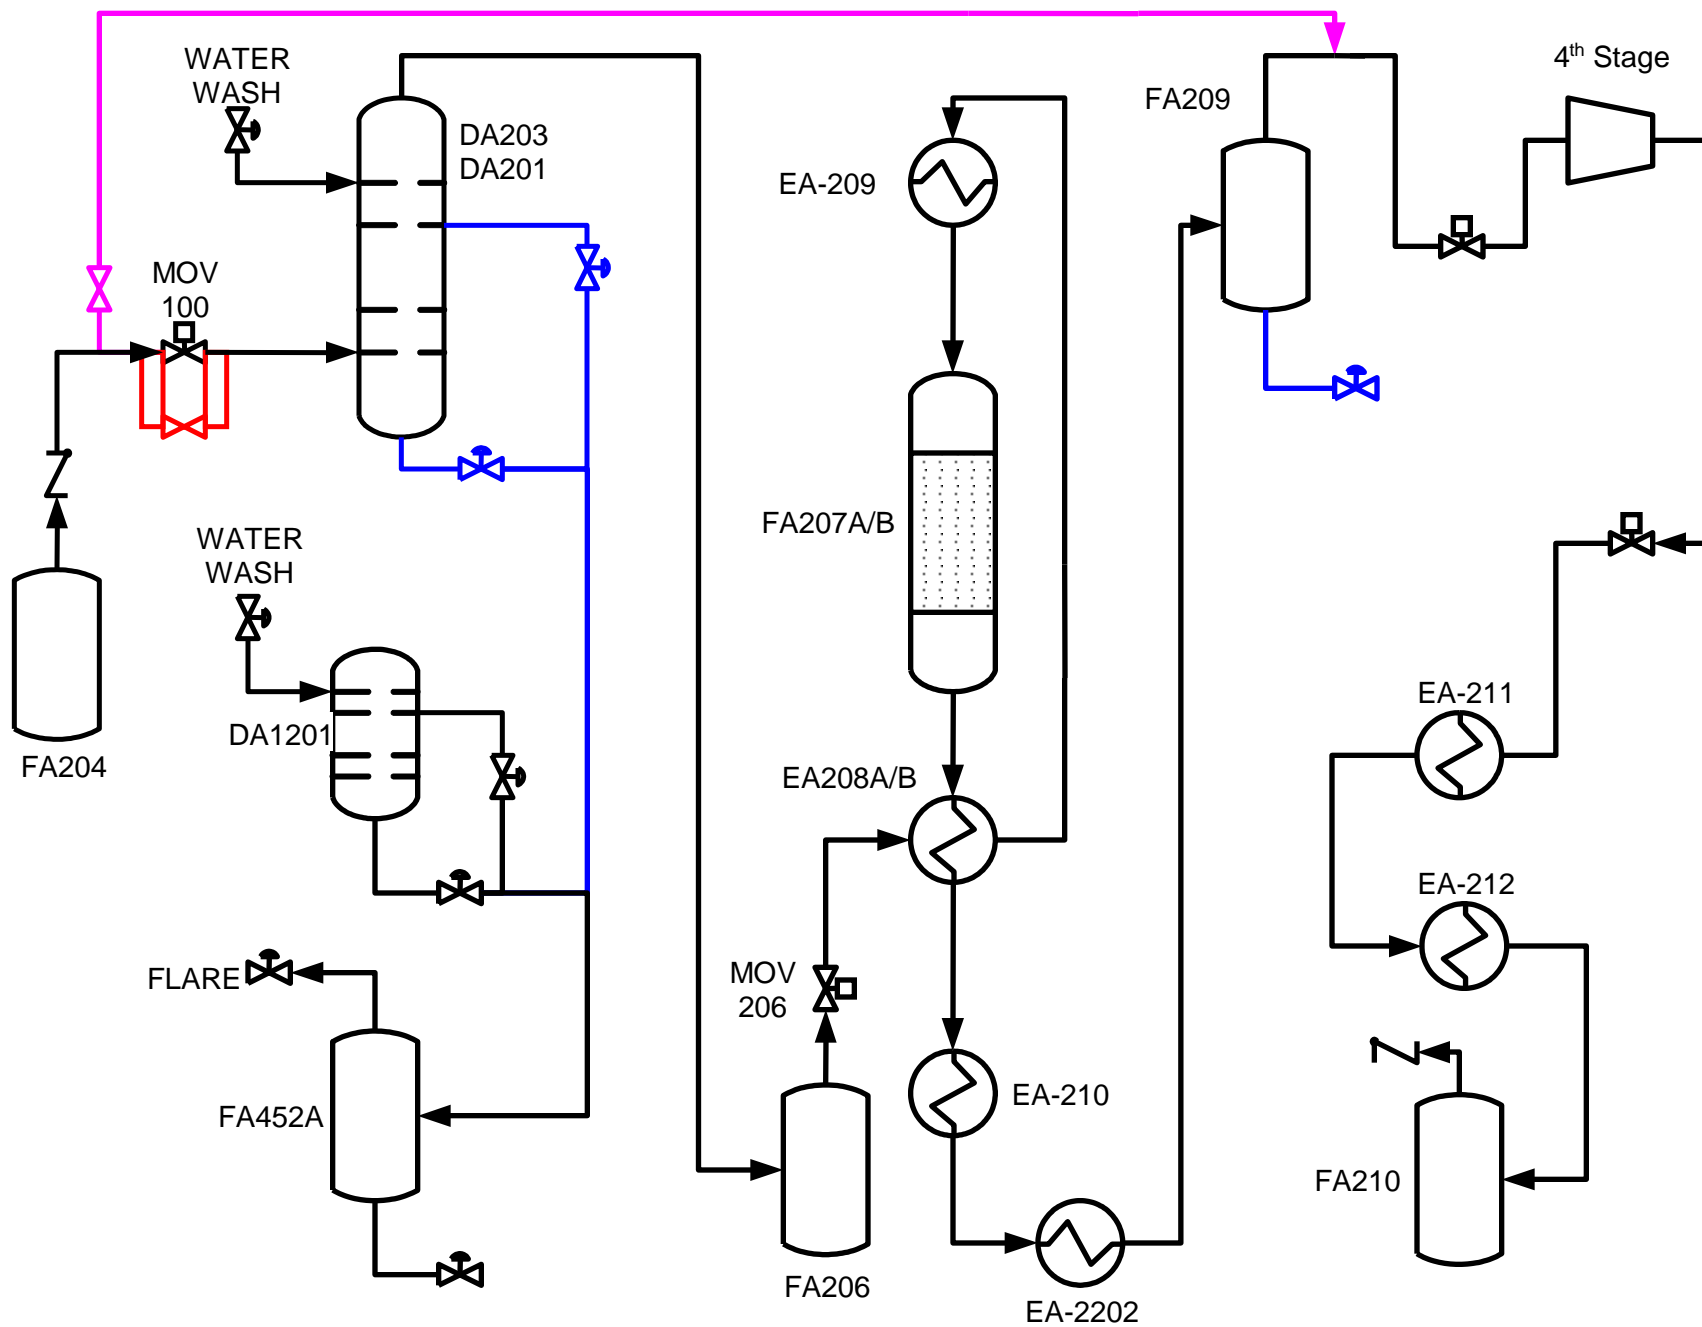
- Misvalving Caustic Wash System Backed Caustic Water into Fourth Stage Compressor Case
- Case Drains Plugged

- High Vibration Due to Rotor Unbalance from Loss of Antifoulant Coating
- Coating Loss due to Caustic Water Filling Casing While Charge Gas Compressor Train Down for 2/3 Stage Overhaul
- Procedures and Check-sheet have been Revised to Prevent Recurrence
